basic imagery interpretation report

## Soviet Mobile Missile Summary

DEPLOYED STRATEGIC SSM FACILITIES  
BE: VARIOUS  
USSR

RCA-05/17/83  
NOVEMBER 1983  
Copy 42

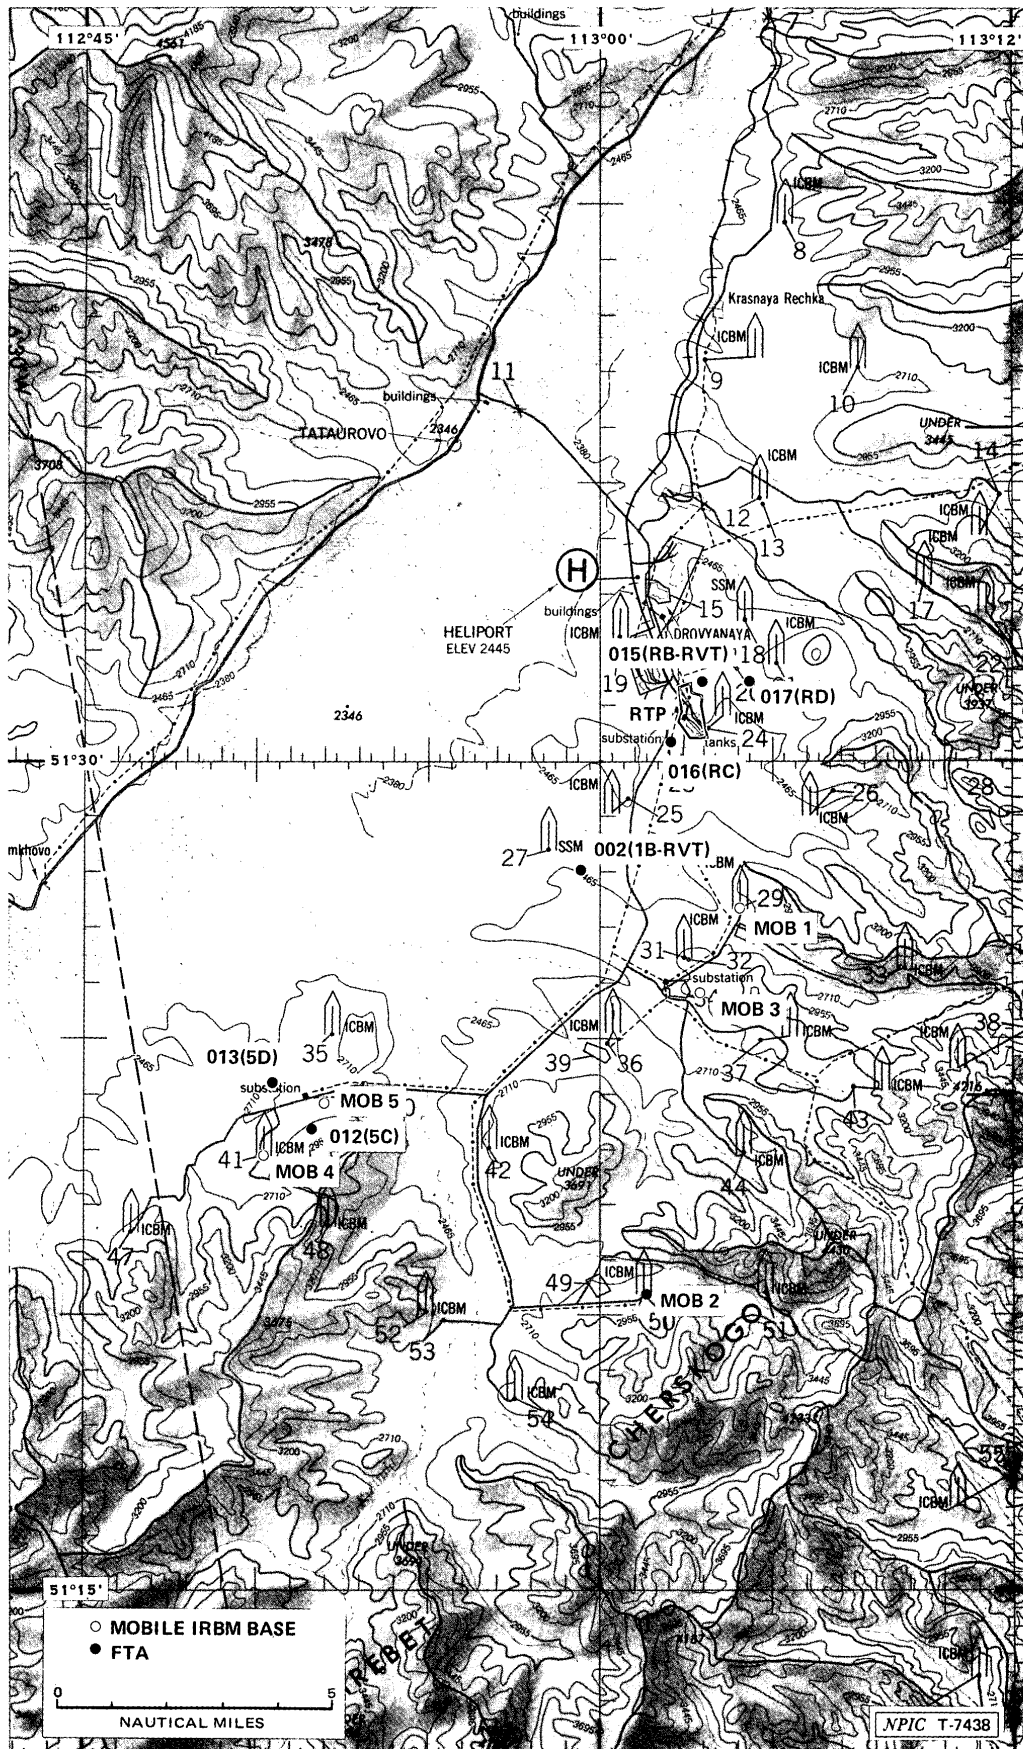
FIGURE 2. SS-20 FTxs AT DROVYANAYA SSM COMPLEX

5. **Drovyanaya SSM Complex** [ ] On [ ] six SS-20 FTXs were observed field deployed in the Drovyanaya SSM Complex (Figure 2). (Three of these six had also been observed on [ ] Two FTXs were underway near Drovyanaya Mobile IRBM Base 5: at Drovyanaya FTA 012 [ ] and Drovyanaya FTA 013 [ ] At FTA 012, a camouflaged SS-20 launch battalion consisting of three SS-20 TELs with canisters and nine SS-20-associated vehicles was present (Figure 3). At FTA 013, a camouflaged SS-20 C3 unit consisting of seven MSVs, five SS-20-associated vehicles, two trucks (not camouflaged), and two tents was observed. A ground-mounted antenna mast was discernible near a camouflaged probable [ ] meter MSV (Figure 4). In the general support area of Mobile IRBM Base 5, a truck-mounted TWIN EAR troposcatter antenna in travel mode and associated generator trucks, an APC, and one truck were in front of the open doors of two 11-bay garages. The vehicles appeared to be preparing to depart the base, probably to go to FTA 013, where the C3 unit was deployed. (S/WN)

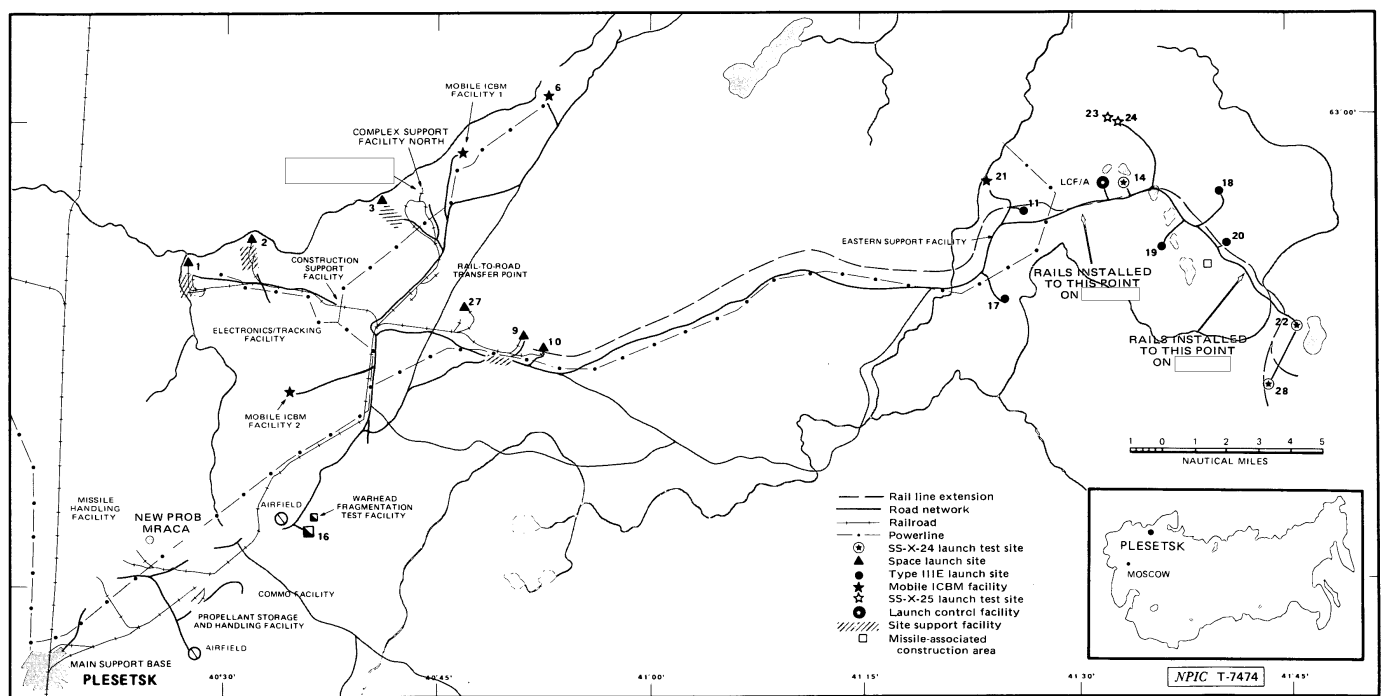
FIGURE 38. MAP OF PLESETSK RAIL EXTENSION

[ ] was progressing at a rapid pace. Additional ballast for the railbed continued to be added and graded in numerous noncontiguous segments along the rail right-of-way to LTS 28. By the end of the reporting period, rails were installed to within 2.5 nm of LTS 28. If the pace of construction observed is continued, rails may reach LTS 28 before the end of 1983 (Figure 38). (S/WN)
